WINDFARM MOSCHKOGEL IN THE AUSTRIAN ALPS

Hans Winkelmeier / energiewerkstatt°

Wind Farm Moschkogel

Operational experience during winter at WF Moschkogel

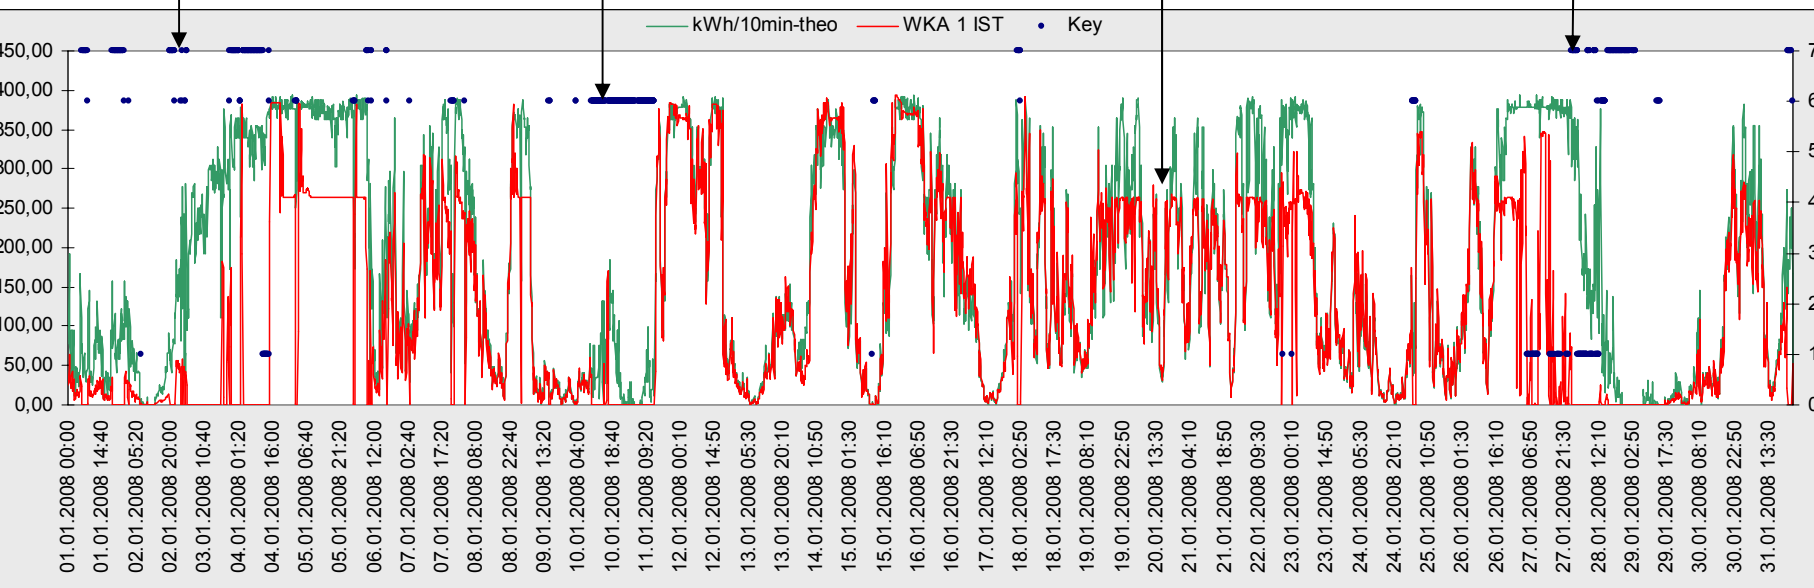
Operational data (example)
January 2008

Code No.7:
„Standstill by icing“

Code No.6:
„Maintainance or failure“

No Code:
„Reduced Power“

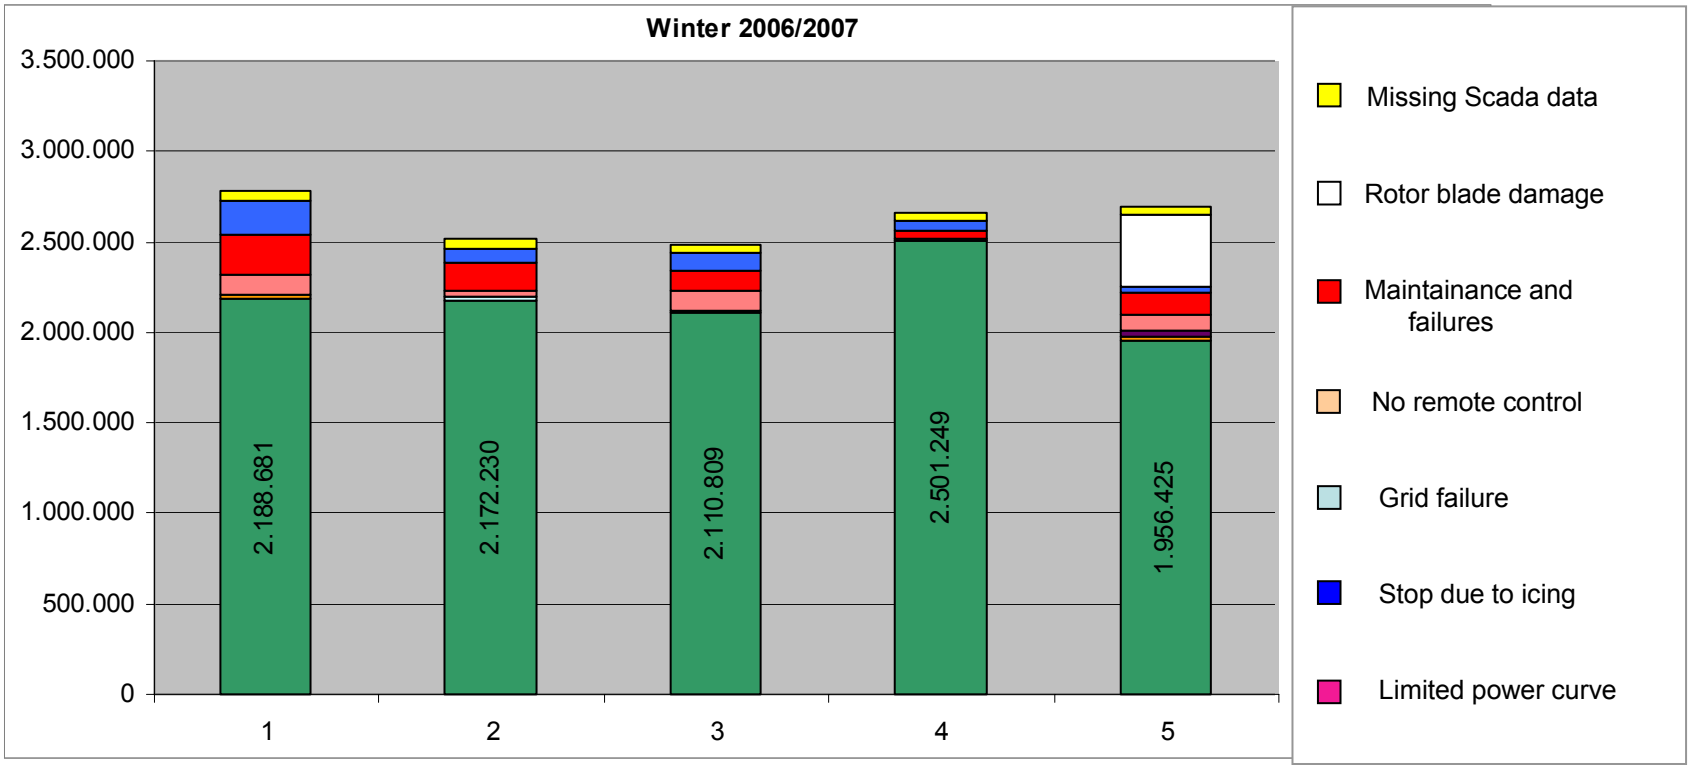
Production and calculated losses during winter 2006/2007

- During winter 2006/2007 all 5 turbines were equipped with an ENERCON de-icing system using electric heating elements.
- Although this winter was a „gentle“ one, the losses caused by icing have been quite high. The main reason for the losses was the damage of one blade heating element at turbine No. 05.
- On other reason for losses was the long standstill time beween automaticaly turbine stop and manual start of the heating
- Total availability of the windfarm including standstills by icing during winter 2006/07: 88.0%

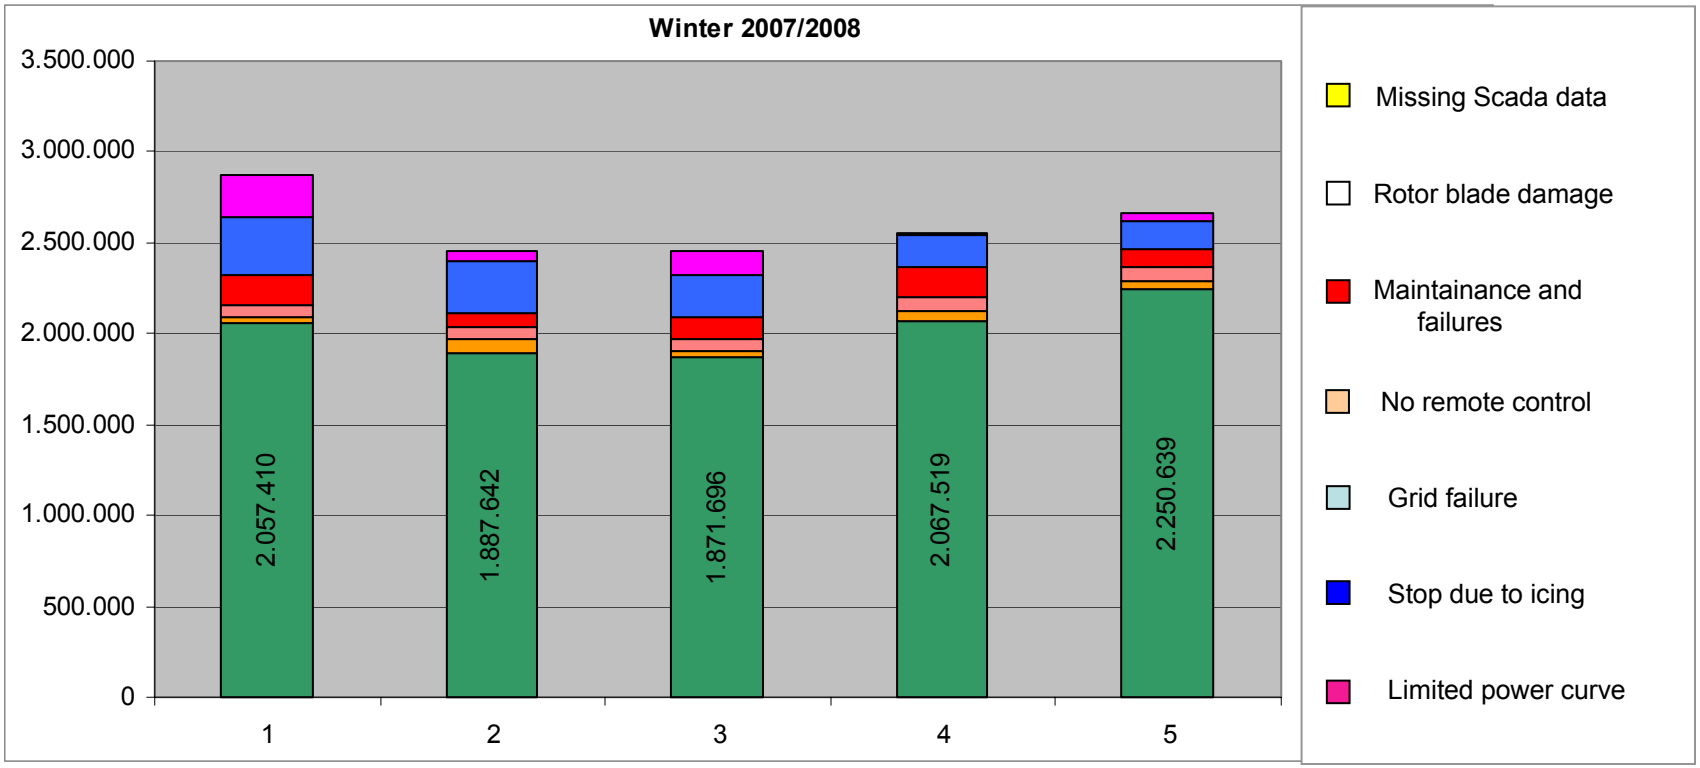
Production and calculated losses during winter 2007/2008

- Winter 2006/2007 was the second year of operating the electric heating elements.
- Main reason for losses was again the long standstill time between automatic turbine stop and manual start of the heating (1-3 hours, heating time is included in „T6-maintainance“). The wind farm attendant had to spend much time at the site, because each single turbine had to be supervised and re-started manually.
- Also the blade heating has been affected by lighning during summer time.
- Total availability of the windfarm including standstills by icing during Winter 2007/08: **86.8%**

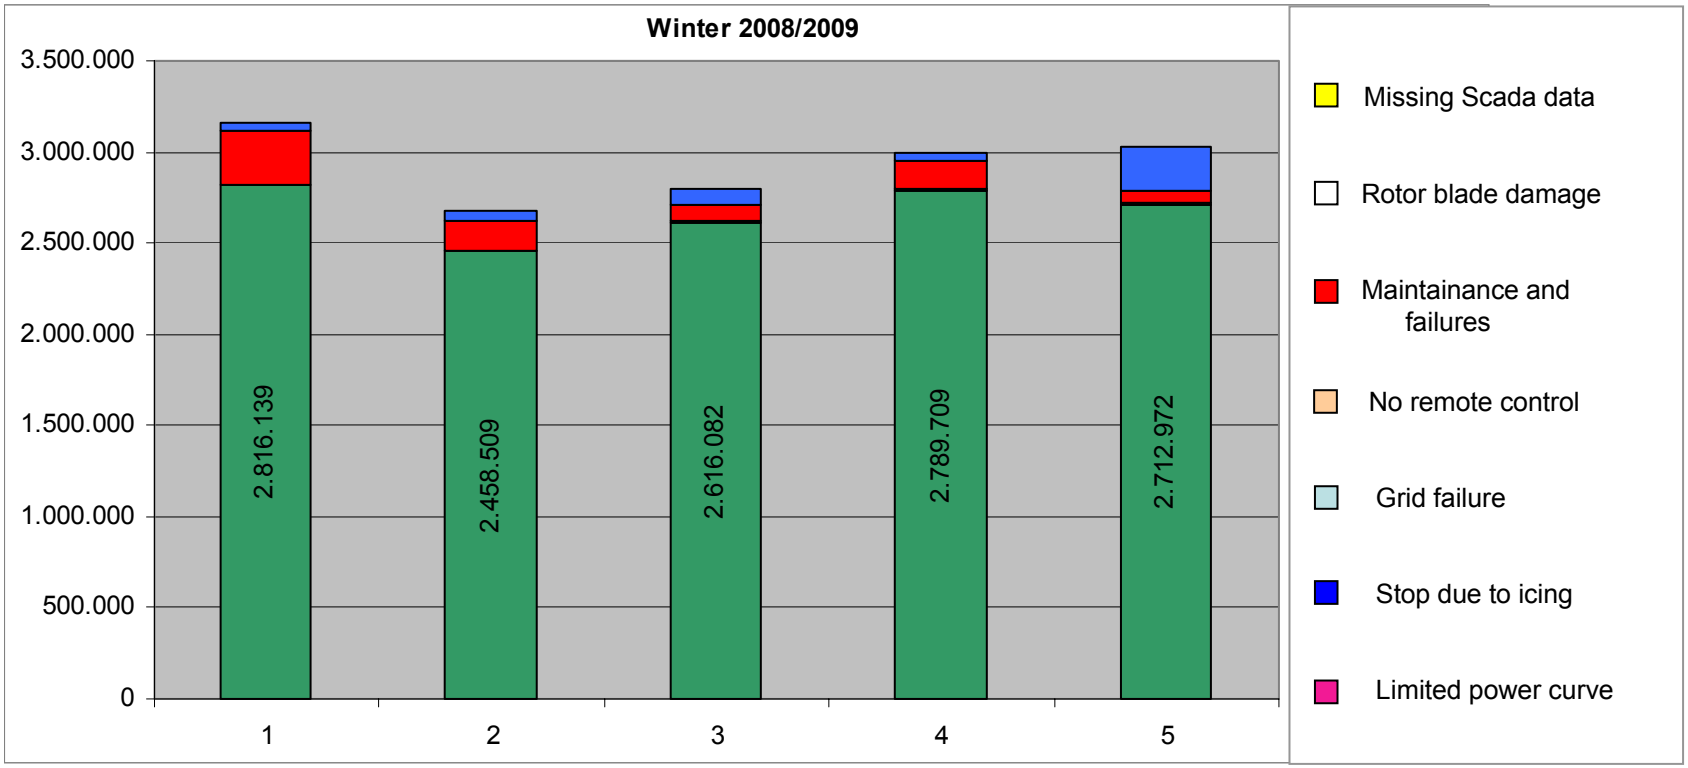
Production and calculated losses during winter 2008/2009

- In summer 2008 the rotorblades of all 5 turbines have been changed and equipped with the new ENERCON blade heating system which heats by warm-air circulation
- The new blade heating system also had to be operated manually during the first winter.
- The effect of de-icing has been sufficient.
- Total availability of the windfarm including standstills by icing during Winter 2007/08: **93.7%**

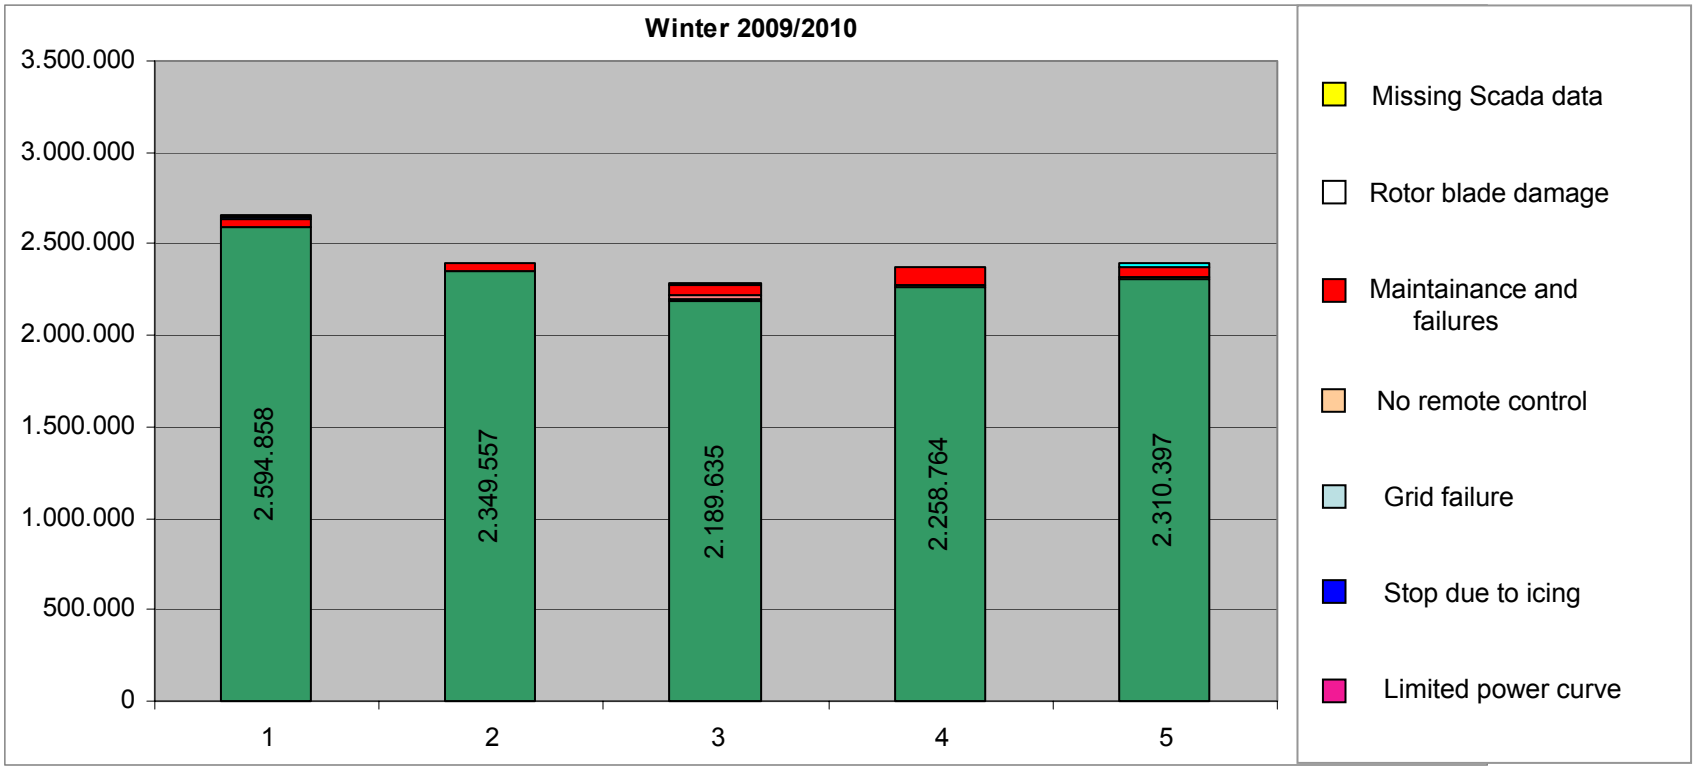
Production and calculated losses during winter 2009/2010

- Winter 2006/2007 was the second winter of operating warm-air circulation heating.
- Now the system has been operated automatically and during operation of the turbine (Anti-Icing).
- A special „counter“ checks if „Aniti-icing“ during operation works efficient. If anti-icing is not able to keep the rotor blades free of ice, the turbine is stopped and „De-icing“ is started automatically.
- The effect of „Anti-icing“ has been excellent and it seems, there is no danger of falling down of bigger pieces of ice during heating time.
- Total availability of the windfarm including standstills by icing during Winter 2009/10: 9**7.8%**
